# TUBULAR FRONT UPPER CONTROL ARM FOR 2-4" LIFT

(2007-2021 TUNDRA)

### INSTALLATION INSTRUCTIONS

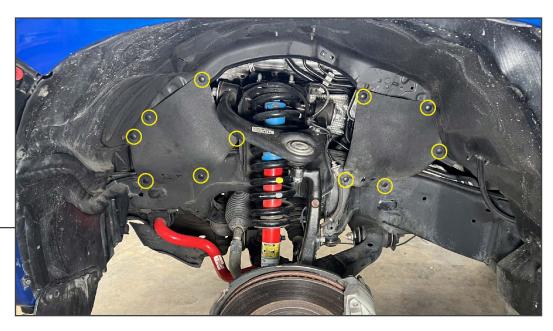
Lift and support the vehicle using a floor jack and jack stands. Remove the wheel from the vehicle.

Using a panel removal tool, remove the splash shields on each side of the vehicle strut.

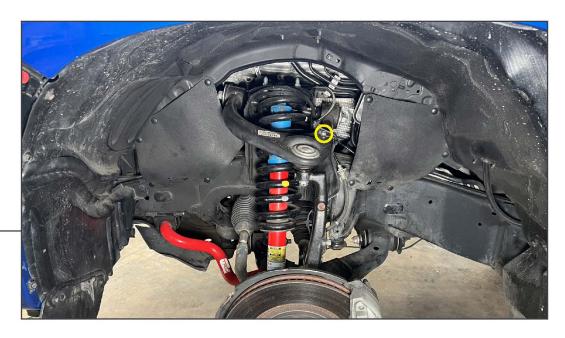
STEP 2

Remove (1) 10mm bolt from the top of the upper control arm to release the ABS line bracket.

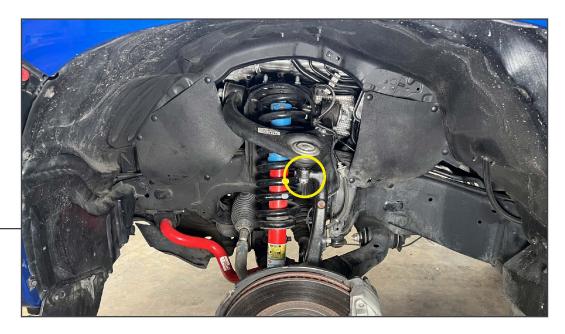
Remove the upper ball joint cotter pin. Then loosen, but do not remove, the (1) 19mm ball joint nut.

With the nut loose, strike the steering knuckle with a hammer to dislodge the ball joint from the knuckle. With the ball joint dislodged, use a pry bar to pry downwards on the control arm to remove the nut, then lower the steering knuckle away.

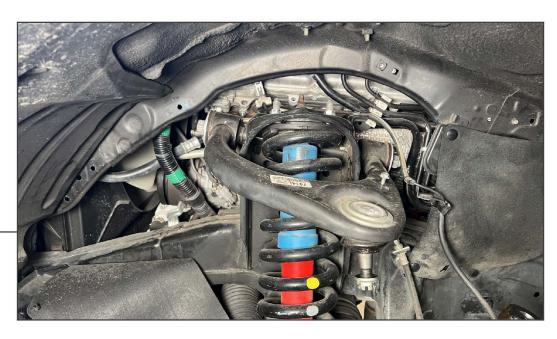
STEP 4

The vehicle uses (1) through-bolt through the vehicle frame to secure both ends of the control arm.

Using a 22mm socket and wrench, remove the nut from the control arm through bolt. Then, remove the head of the bolt towards the front of the vehicle.

**Note:** Gently massaging engine bay components may be necessary for additional clearance. Ensure to identify the direction of the bolt washers during removal.

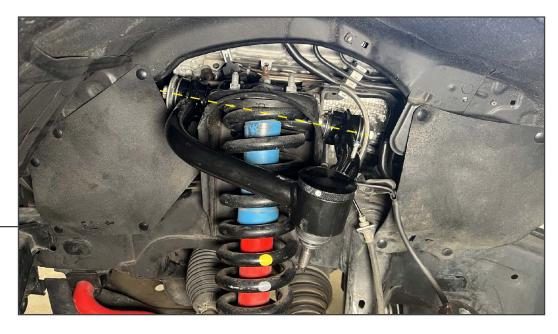
Install the new control arm to the vehicle reusing the original 22mm bolt. Do not fully tighten the bolt at this time. The control arm mounting bolt will be tightened with the vehicle on the ground with the suspension loaded.

**Note:** Using a rubber hammer and/or pry bar to fit the control arm to the vehicle frame mounts may be necessary. Due to the control arm mounting design, take your time to align the bolt to the control arm & frame hole.

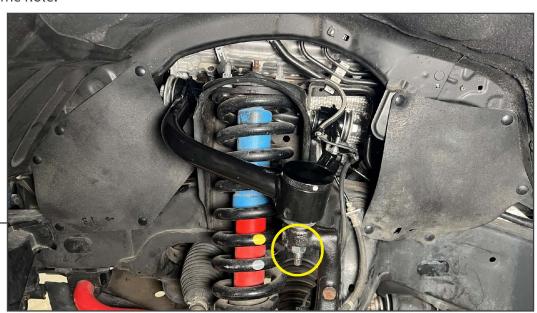
## STEP 6

Secure the control arm ball joint to the vehicle steering knuckle using the (1) 19mm lock nut.

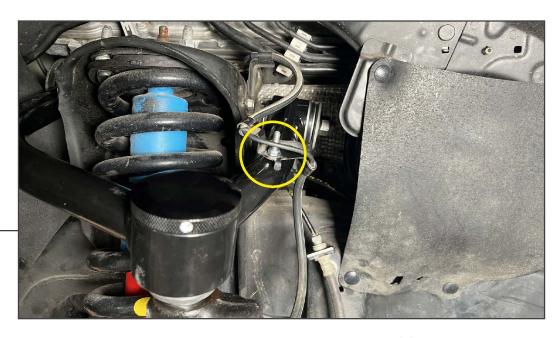
Secure the ABS line bracket to the new control arm stud using the included (1) 10mm lock nut.

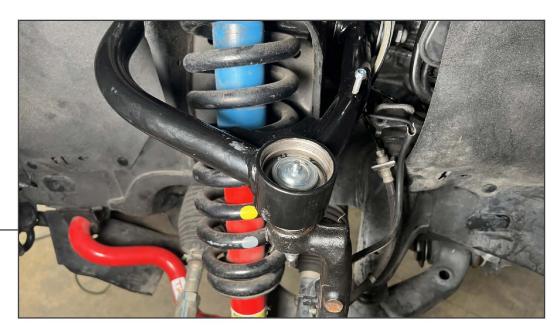
STEP 8

Turn the ball joint cap counter-clockwise to remove the ball joint cap to reveal the grease fitting. Fill the ball joint with synthetic grease until full, do not overfill.

With the ball joint greased, re-install the cap.
